# RESIDENTIAL ROOF CONDITION REPORT

[REDACTED] · Inlet Beach, FL

# ROOF INSPECTION REPORT

Drone-Assisted Visual Assessment

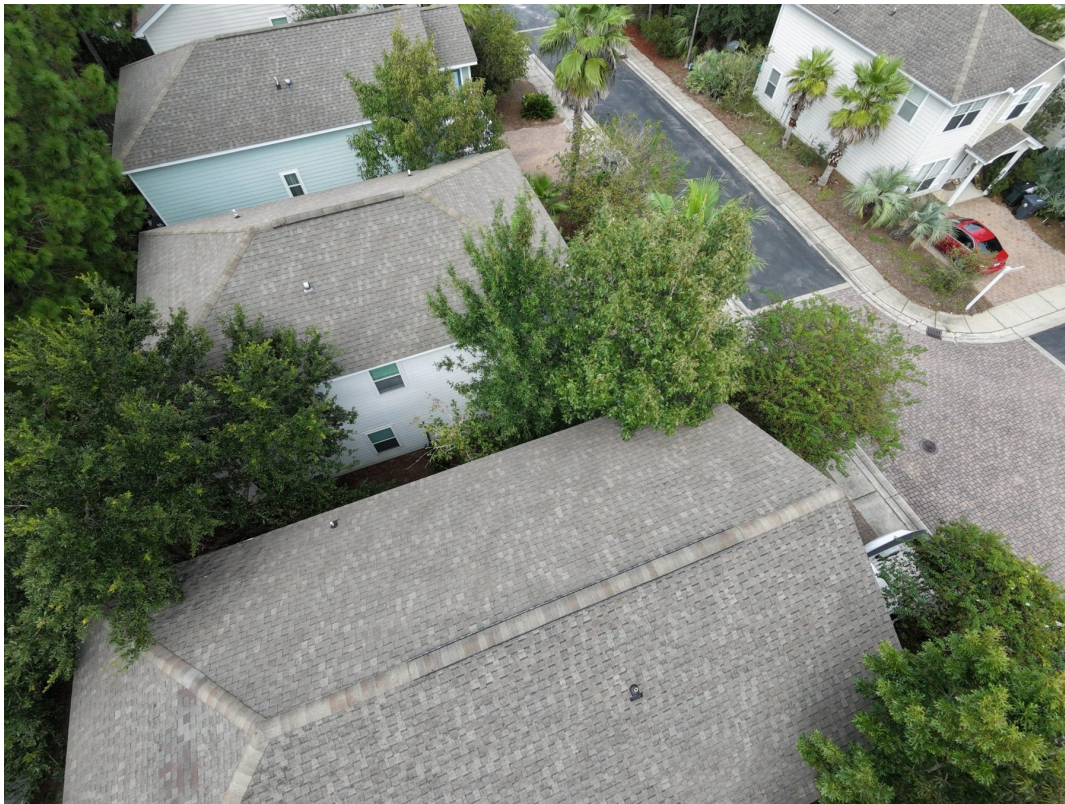
### Photograph 1: Property Context — Roof & Surrounding Trees

- Granule coverage appears intact in the close-up views, and no cracking, blistering, or curling was visible in the areas shown (Photos 7 and 8).
- Mature trees are close to the roof, with branches overhanging the roof edge and lower slopes (Photos 1, 3, 4, and 10). Overhanging growth drops debris, holds moisture, and can abrade shingles (Low to Moderate).

Wide oblique view showing the gray asphalt shingle roof at [REDACTED] (foreground) with neighboring homes, the street, and dense mature trees. Tree canopy is close to the roof on the left and along the near edge, which limits sun exposure on parts of the roof and puts leaf litter and branch contact within reach of the shingles. A roof vent and the main ridge and hip lines are visible. No missing sections or large-scale defects are visible from this height.

- Have the roof professionally cleaned with a low-pressure soft-wash and algae treatment to remove the dark staining (Photos 3, 5, 7, and 8). Avoid pressure washing, which can strip shingle granules.
- Trim back branches that overhang or touch the roof, especially along the edges shown in Photos 1, 3, 4, and 10, to reduce debris, shade, and moisture.
- Clear leaf litter and debris from the roof surface, valleys, and gutters if present.
- Have a roofing contractor check the plumbing vent boot (Photo 9) for a proper seal and shingle lap, and re-seal if needed.
- Monitor the reddish-brown tabs near the top of the hip face (Photo 2) for any lifting or sealant failure.
- Re-inspect in 12 months or after a significant weather event (high winds, hail, heavy rain).

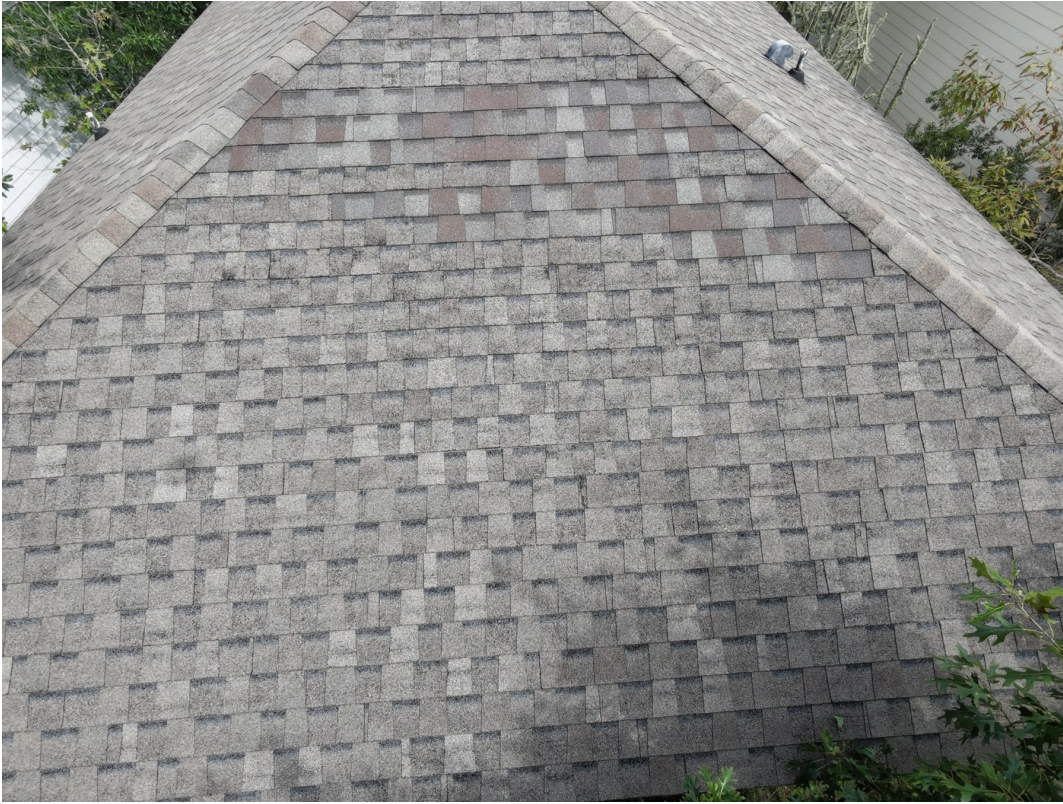
## Photograph 2: Hip Face Overview — Shingle Field & Ridge Caps

- A cluster of reddish-brown tabs near the top of the hip face (Photo 2) appears to be part of the color blend or an earlier tab replacement; no gaps or lifting visible (Low).

Head-on view of a hip-shaped slope bounded by ridge caps on both sides. The field shows even gray weathering with scattered darker staining toward the lower half. A cluster of reddish-brown tabs near the top of the slope appears to be part of the shingle color blend or an earlier tab replacement; this cannot be determined from the image, and no gaps or lifted tabs are visible there (Low). A roof vent sits at the upper right near the hip line. Tree growth and siding are close on the right.

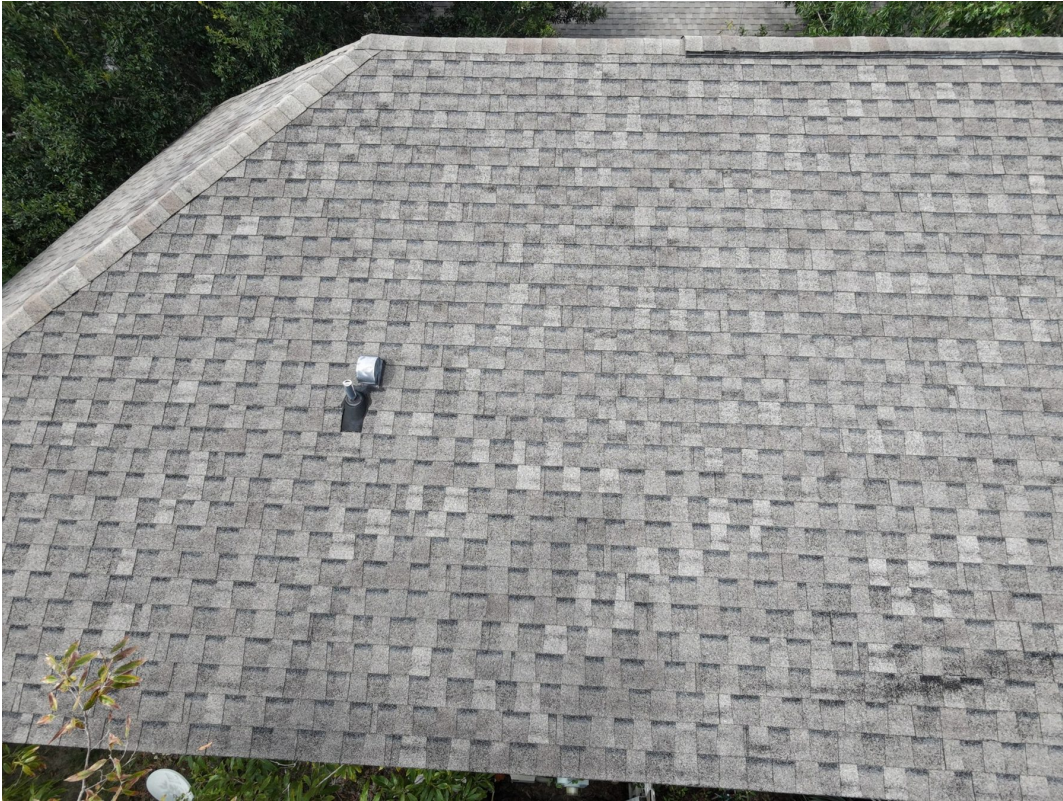
### Photograph 3: Slope View — Vent, Hip Line & Eave Staining

- Widespread dark staining and streaking on many tabs, heaviest on the lower courses and near the eaves (Photos 3, 5, 7, and 8). The pattern is consistent with algae or biological growth, though it cannot be confirmed from images (Moderate).

Wide view of a slope with a roof vent near the center and the hip line along the upper left. Shingle courses are straight and consistent. Dark streaking and darker tabs are visible toward the lower right and along the lower courses near the eave (Moderate; consistent with algae or biological growth). Nearby foliage hangs over the lower right corner.

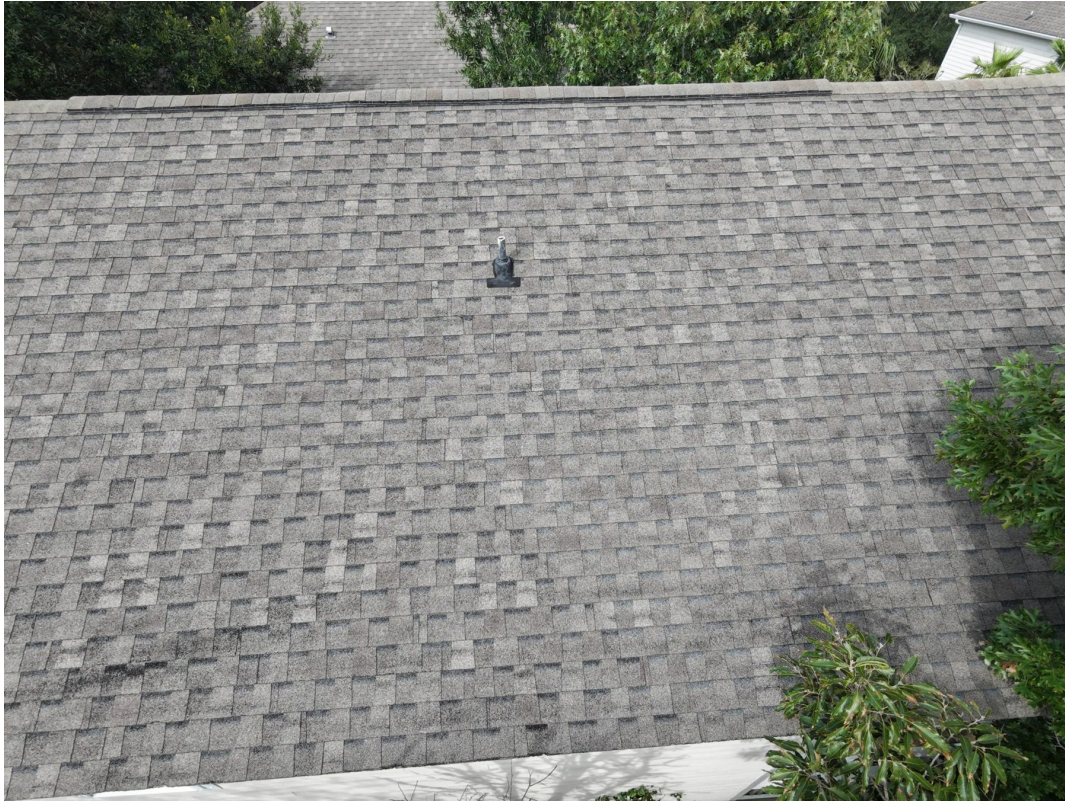
#### Photograph 4: Upper Slope — Ridge Line, Vent & Overhanging Foliage

View of a slope below the ridge with a roof vent near the center. The ridge cap line at the top is continuous. Darker staining is concentrated in the lower left and along the lower courses, and tree branches extend over the lower right edge of the roof (Low to Moderate). No missing or lifted shingles are visible.

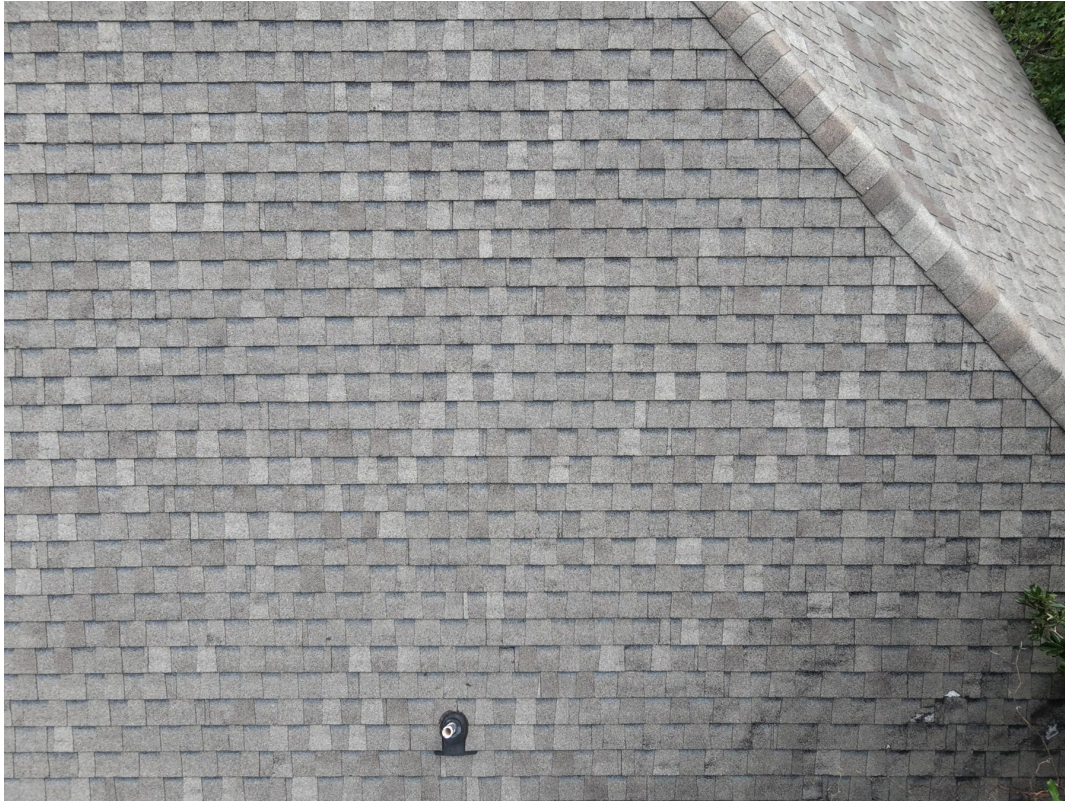
### Photograph 5: Broad Slope — Ridge Transition & Plumbing Vent Boot

Large continuous slope with a ridge or hip transition running diagonally across the upper right. Shingle courses run straight with consistent exposure. A plumbing vent boot is visible near the bottom edge, and scattered dark staining appears along the right side and lower courses (Moderate). No cracked, curled, or missing tabs are visible.

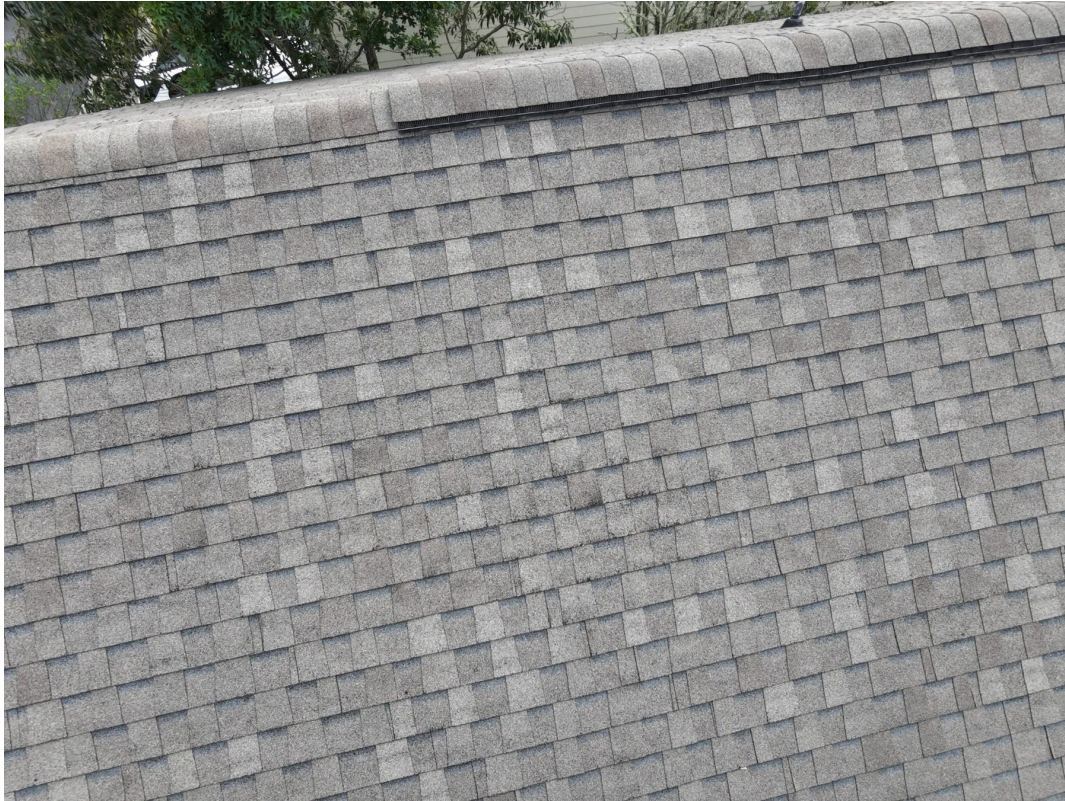
### Photograph 6: Ridge Cap & Ridge Vent Detail

Angled view of the ridge. The ridge cap shingles are aligned and continuous, and a black ridge vent strip runs along the ridge beneath the cap. A small vent stack is visible at the top right. The slope below shows moderate, even weathering with mild staining on some tabs (Low). No separation, lifting, or displaced ridge caps are visible.

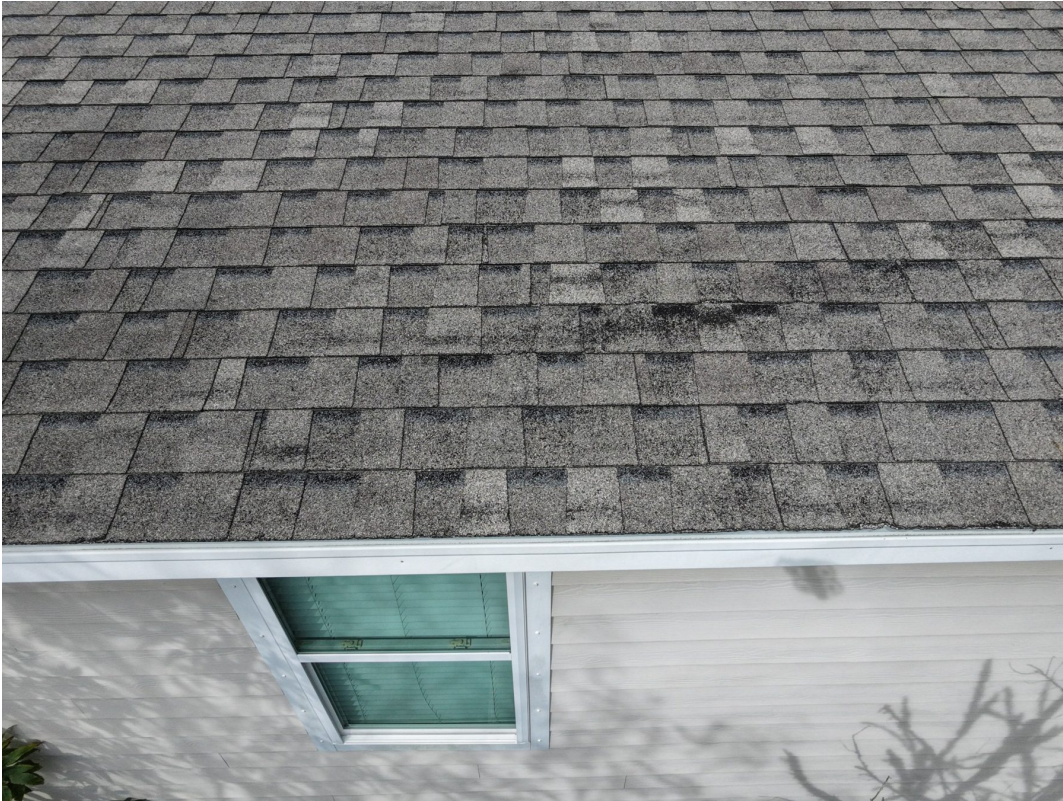
**Photograph 7: Eave Close-Up — Staining Above Window**

Close view of the lower courses above a window and white drip edge and fascia. Dark staining covers a large share of the upper portion of each tab, heavier toward the center of the frame (Moderate; consistent with algae or biological growth). Granules appear present, and no cracking, curling, or missing tabs are visible. The metal drip edge is in place along the eave.

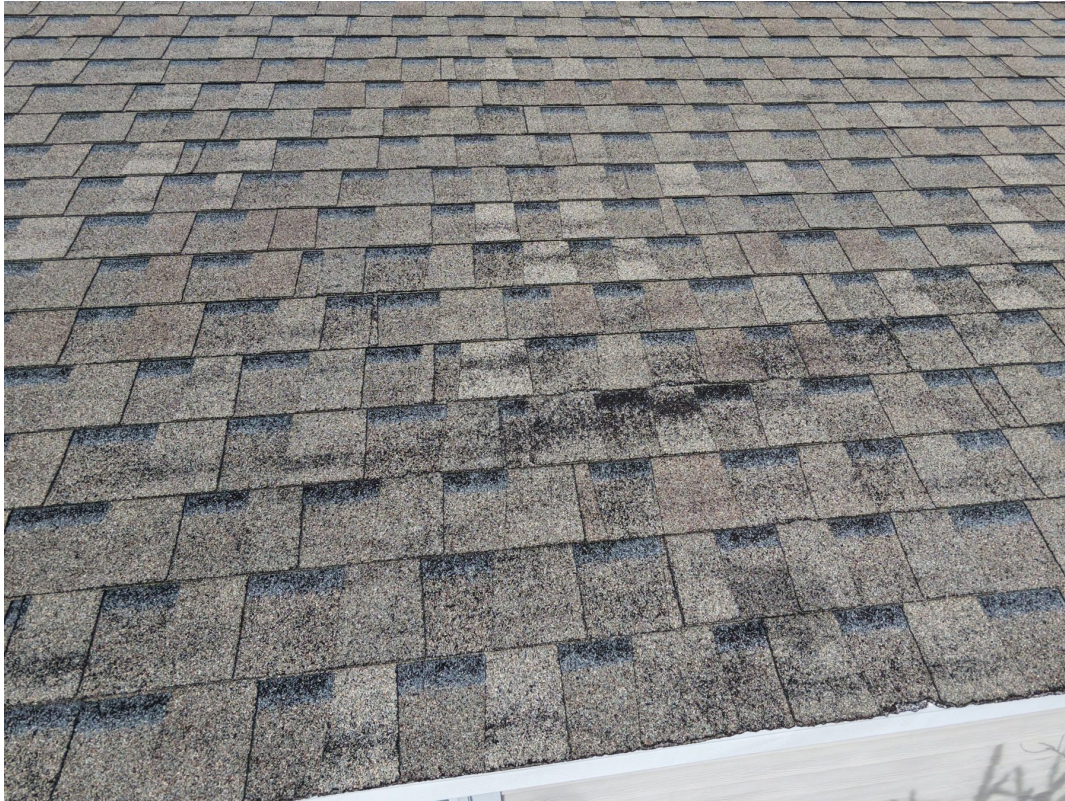
### Photograph 8: Shingle Close-Up — Staining & Color Variation

Detailed angled close-up of the shingle surface. Dark staining and streaking are visible across many tabs, most noticeably at the center and lower right (Moderate). Tab-to-tab color variation, including some brownish tabs, is consistent with the shingle blend. Granule coverage looks intact, and no cracking, blistering, or lifted tabs are visible. White drip edge appears at the lower right.

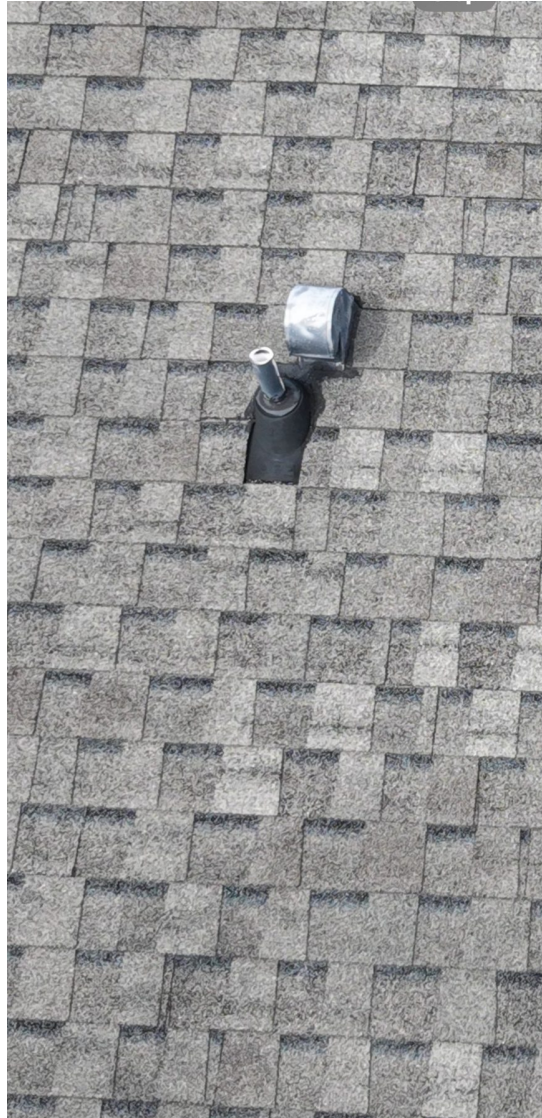
### Photograph 9: Roof Vent & Pipe Boot Detail

- The plumbing vent boot (Photo 9) has shingles cut around it with a dark outline at the base. Whether the shingles are fully lapped over the boot flange and sealed cannot be confirmed from the image (Low; recommend verifying).

Enlarged view of a metal exhaust vent hood with an adjacent plumbing pipe and black rubber boot. The shingles are cut around the boot, and a dark outline is visible at its base (Low). Whether the shingles are fully lapped over the boot flange and sealed cannot be confirmed from this image. The metal hood appears intact, with no visible displacement. A hands-on check of the seal is recommended.

- **Priority:** Low-to-moderate — no immediate repairs identified; address staining and overhanging trees first.
- **Timeline:** Vent boot check and tree trimming within the next 60–90 days; soft-wash cleaning within 3–6 months; next visual inspection in 12 months or after major weather.
- **Action:** Schedule tree trimming and a roof cleaning with a qualified professional, and have a contractor check the vent boot seal.

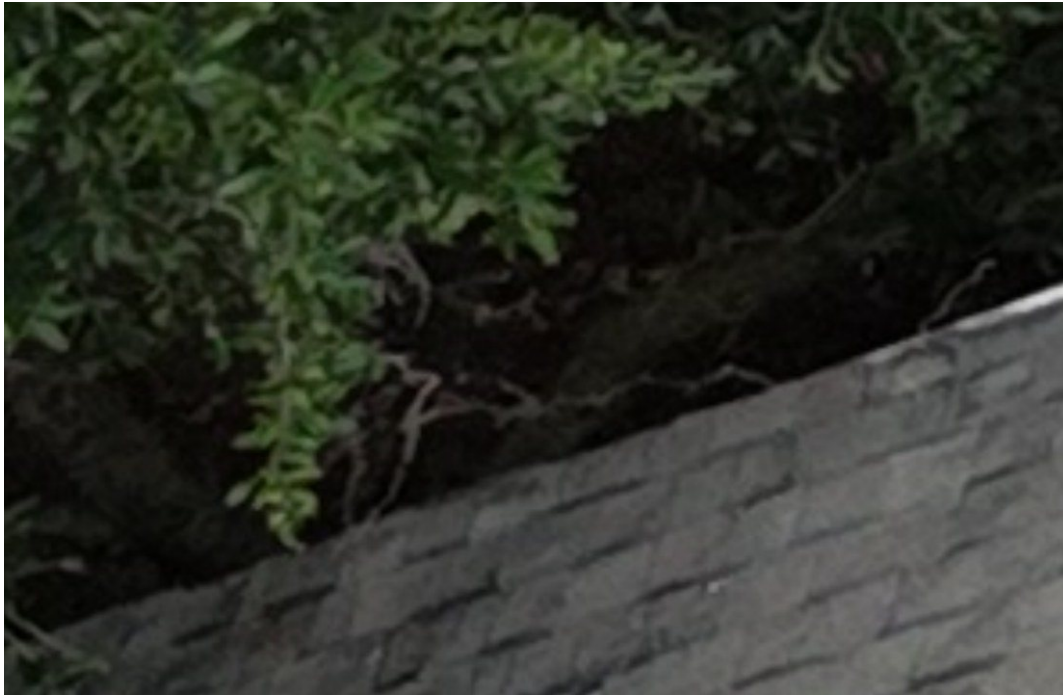
## Photograph 10: Roof Edge Below Overhanging Trees

Cropped, lower-resolution view of a roof edge directly below overhanging branches. Foliage and limbs extend over the roof surface. A few small pale marks are visible on the shingles, and darker staining appears at the left; the marks may be debris and cannot be identified from this image (Low). Image detail is limited, so no condition conclusion is drawn beyond the overhanging growth.
